INDOOR AIR QUALITY ASSESSMENT

**Greenfield Middle School
195 Federal Street
Greenfield, Massachusetts**

Prepared by:
Massachusetts Department of Public Health
Bureau of Environmental Health Assessment
July, 2002

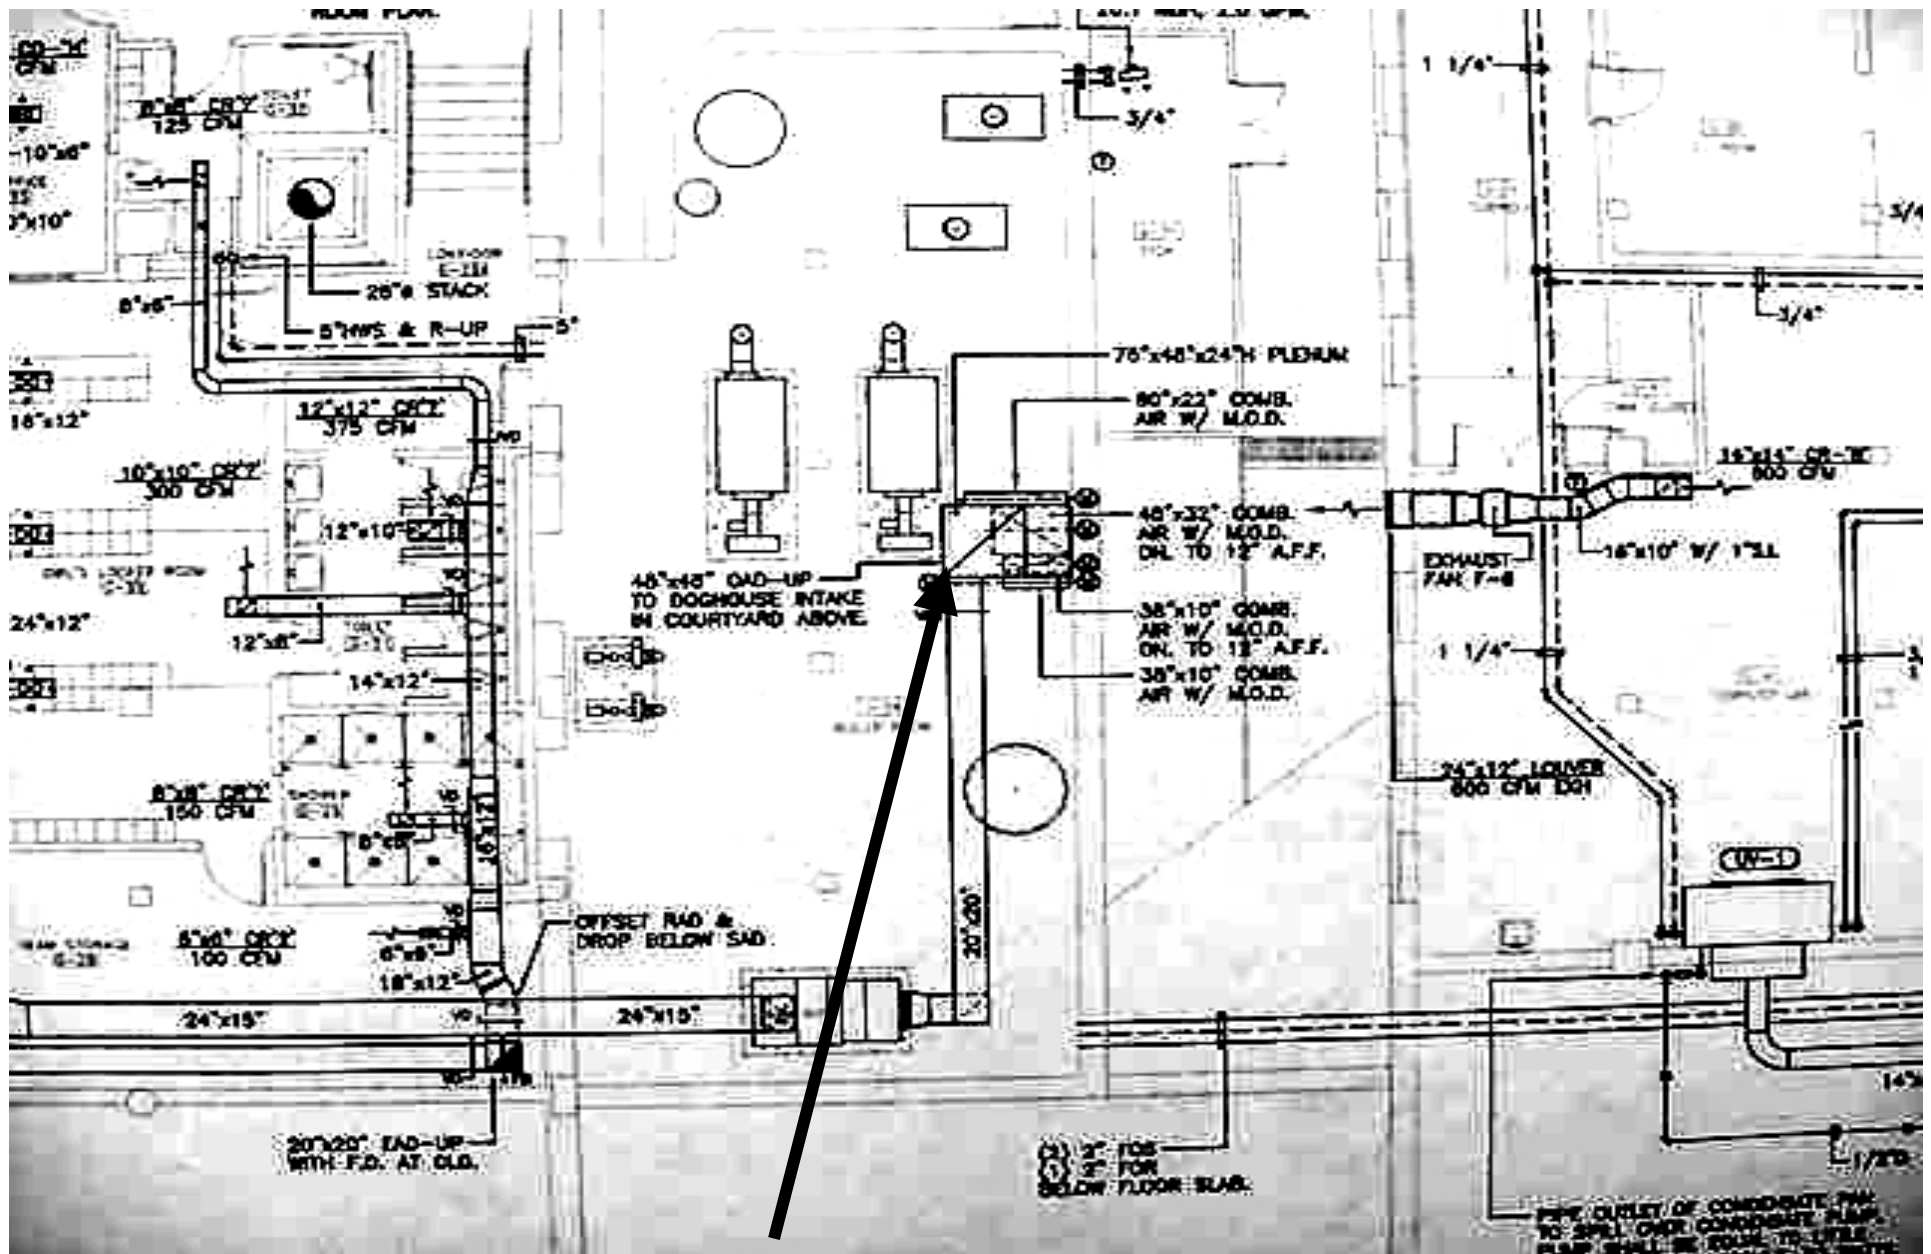
The configuration of the fresh air intake for the locker rooms and the combustion air vent for the boilers may also be problematic. The AHU for the locker rooms is located in the boiler room. According to blueprints, fresh air for the locker room AHU is located in the south courtyard in a structure labeled “the doghouse” (TLCR, 1998; see Picture 16, Blueprint 1). The combustion air supply vent for the boilers is also located within the doghouse. An examination

of the interior of the doghouse structure finds that the locker room AHU fresh air intake and the boiler combustion air vent are not separated, but share the same air duct. In this configuration, the AHU has the potential to draw air and related pollutants from the boiler room. In order for boilers to combust fuel a sufficient supply of oxygen is necessary. The connection of the locker room fresh air intake to the boiler combustion air supply may have the following negative effects if the draw of air by the locker room AHU is greater than the boiler:

Configuration of Boiler Room Ventilation Ducts Connected to “Doghouse”

In this configuration, the AHU should not operate if the boiler is operating. Air distribution to the boilers and AHU are controlled by five separate louver control systems. Ideally, the combustion air supply vent should be separated by ductwork completely from the AHU fresh air intake to prevent the draw of products of combustion.

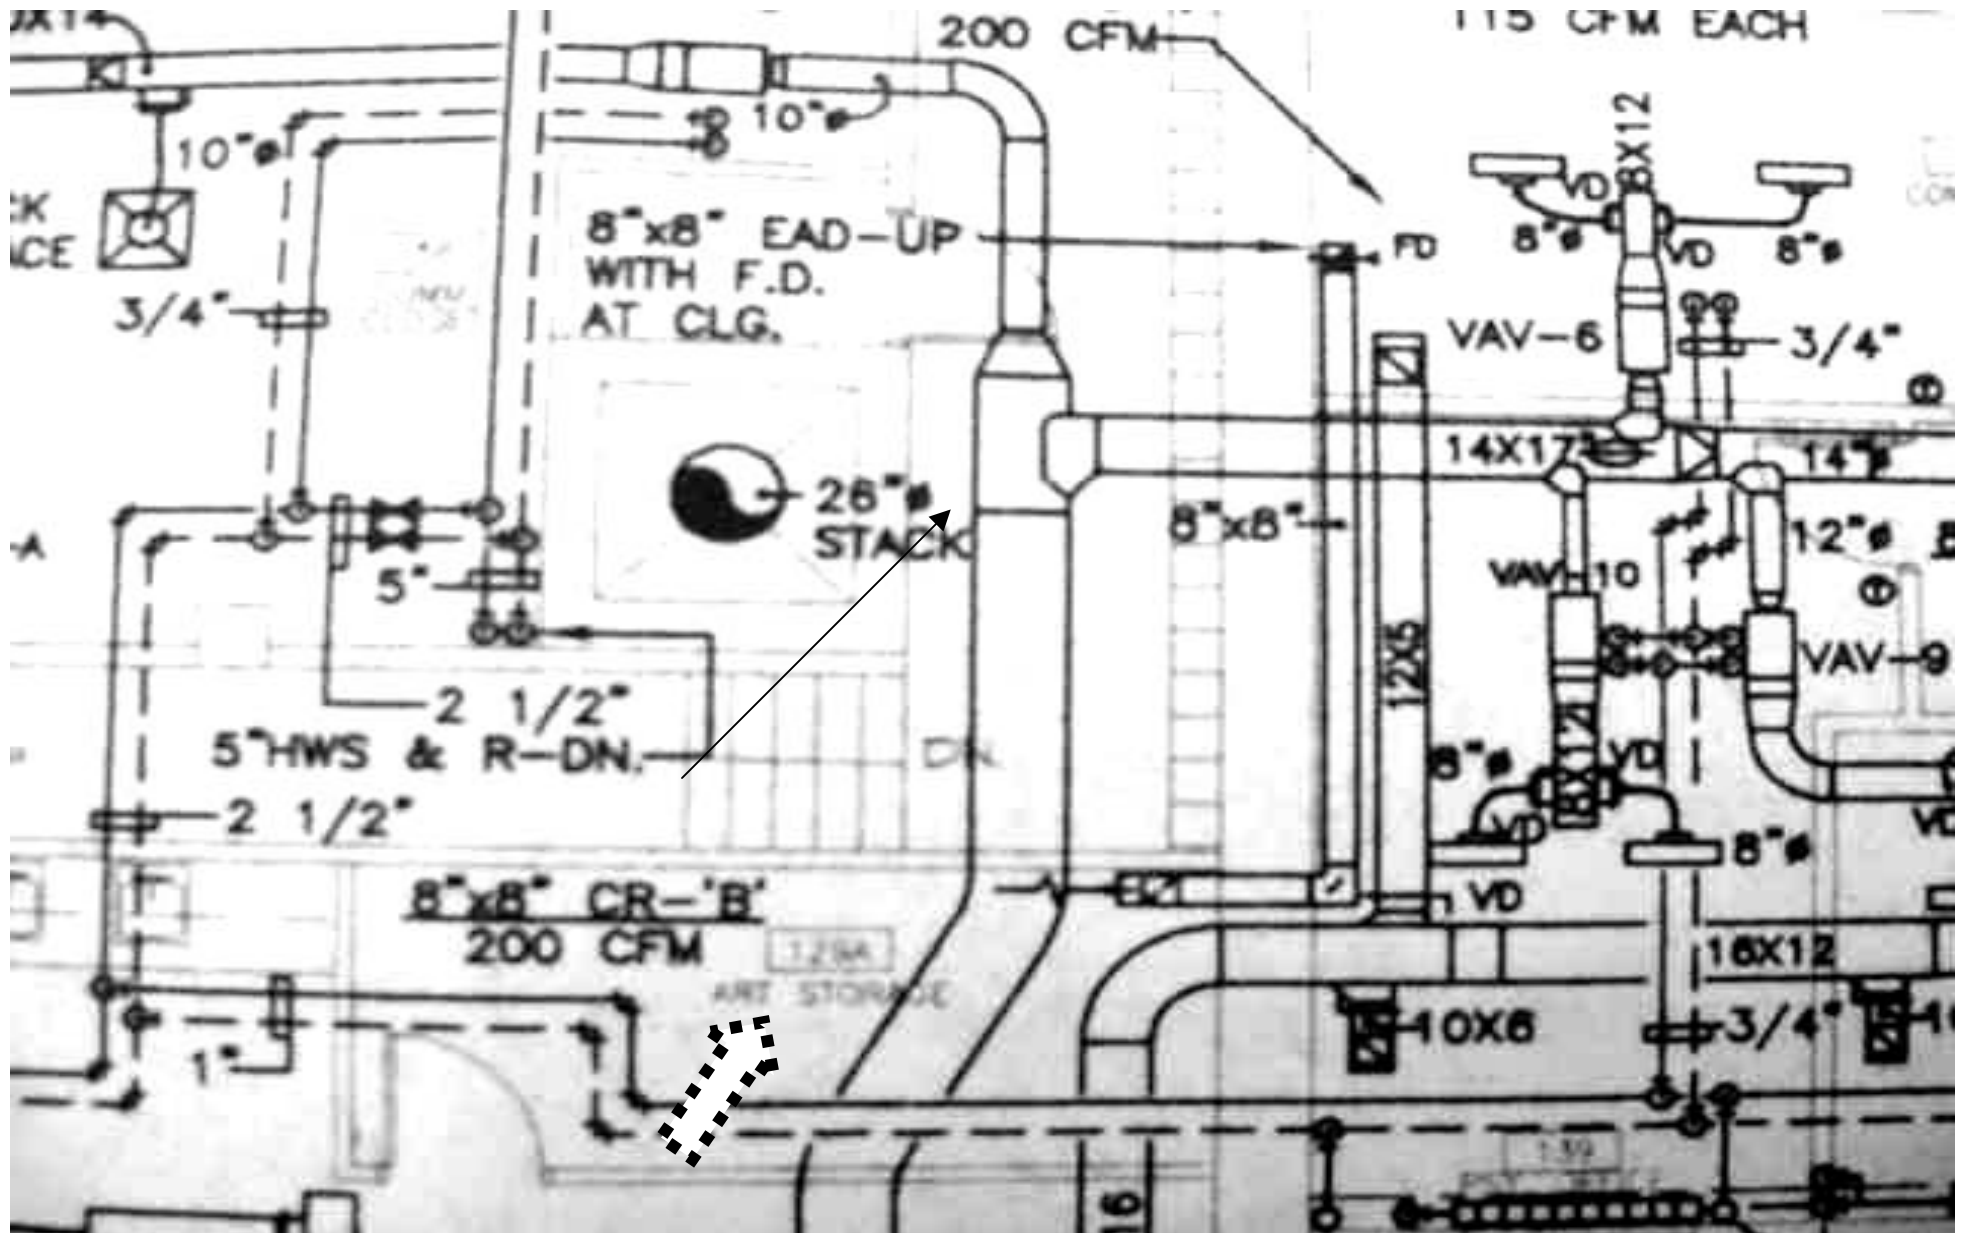
The art room has a pottery kiln in a separate room (TLCR, 1998; see Blueprint 2). The room was originally designed as a storeroom, with an exhaust vent to remove odors from stored materials (see Blueprint 2). In the new set of renovation blueprints, the storeroom was divided in half and depicts the installation of the pottery kiln (CFCI, 2001). A hood was installed above the pottery kiln, which is now connected into the ductwork that originally serviced the storeroom. This configuration may be problematic for the following reasons:

**Original Configuration of Kiln Room, Note Label “ART STORAGE”
(see arrow)**

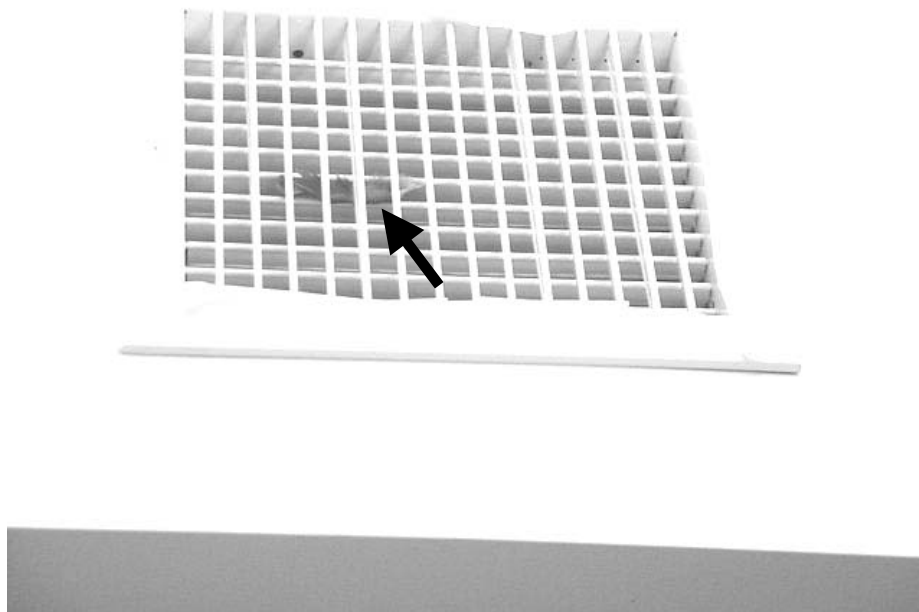
Picture 5

Typical Wall Mounted Fresh Air Diffuser, Note Feather in Louvers

5. Extend the height of sewer vent pipes on the roof a minimum of 2 feet above fresh air intakes for AHUs.
6. The discovery of a bird feather in a fresh air diffuser may indicate the presence of pockets of bird waste in the ductwork. This may require additional cleaning of ductwork. Implement the corrective actions recommended concerning remediation of bird wastes (MDPH, 2000).

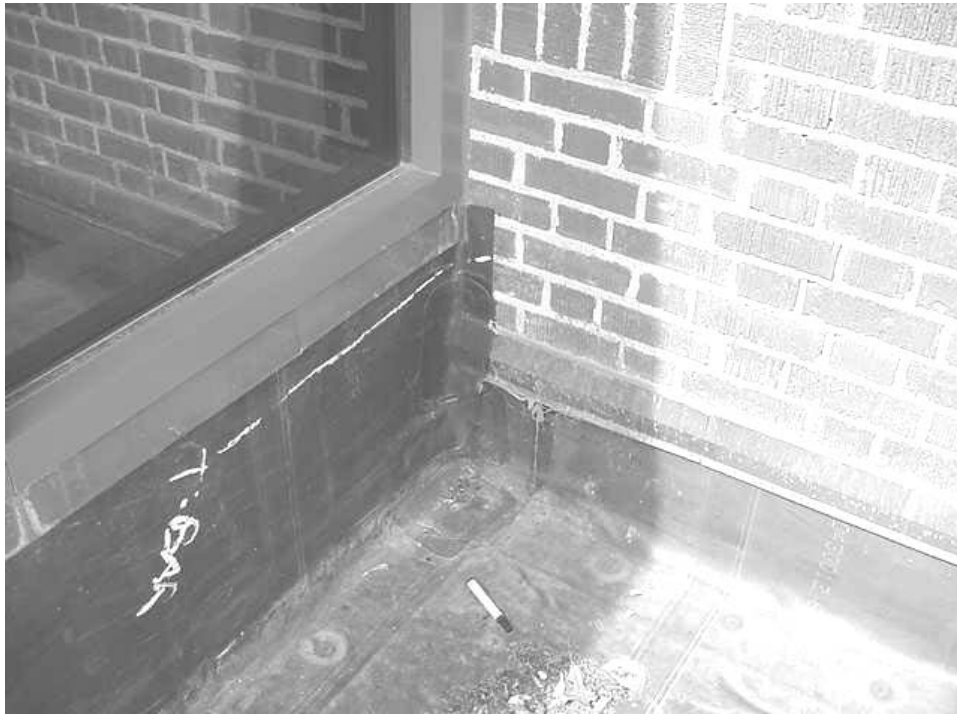
Picture 6

Unsealed Vertical Edge of Roofing Material Adhered to Exterior Wall of Original Building

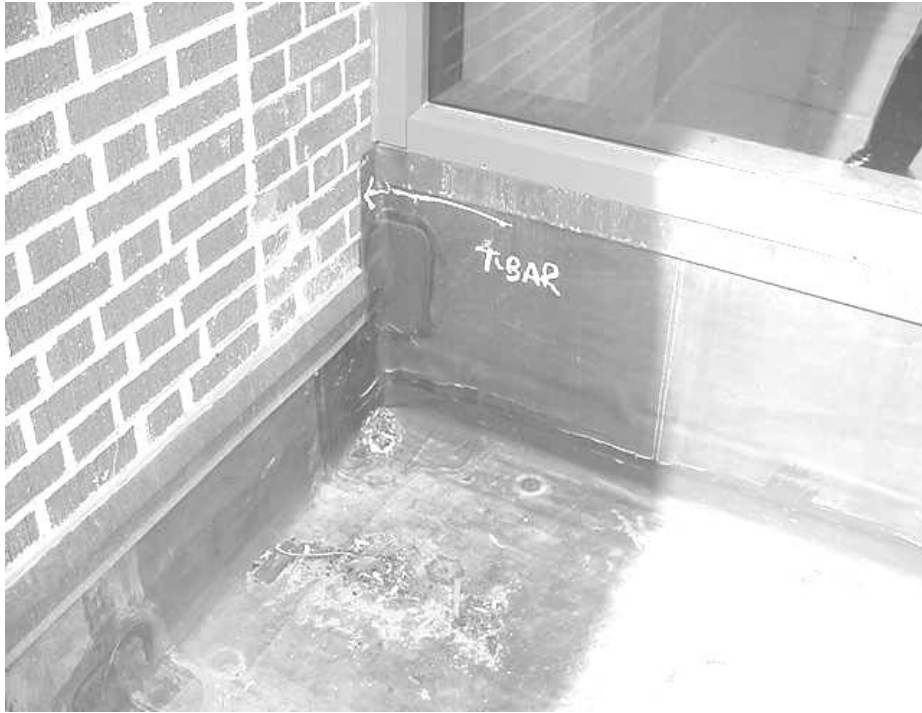
Picture 7

**Unsealed Vertical Edge of Roofing Material Adhered to Exterior Wall of Original Building
Note Spray Painted Instructions**

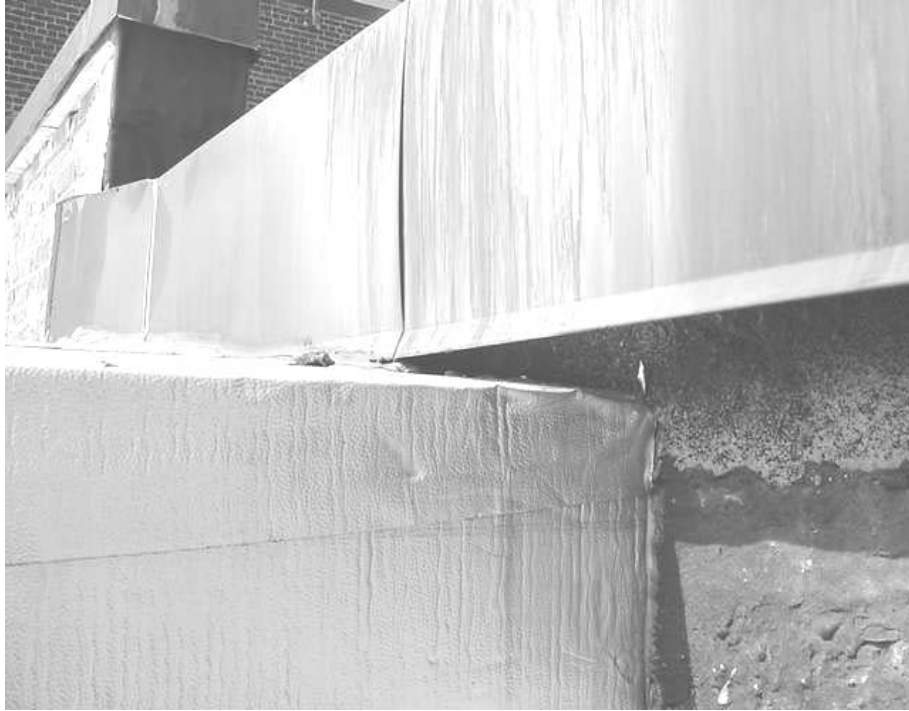
Picture 8

Other defects were noted in the roof. A space the width of Mr. Feeney's hand was found between the exterior wall and ventilation system duct (see Picture 8) for an AHU located on the lower roof. According to Mr. White, this space corresponds to a leak noted below the unit that occurred during a rainstorm with an east wind. A copper roof was installed above a section of the gymnasium. Sections of vertical copper sheets were affixed to other sections of the roof using rivets (see Picture 9). A number of these rivets have failed, allowing for the vertical sections to fan away from the wall (see Picture 10). Under wind driven rain, water may get behind these sections to penetrate through the copper roof.

A Space between the Exterior Wall and Ventilation System Duct

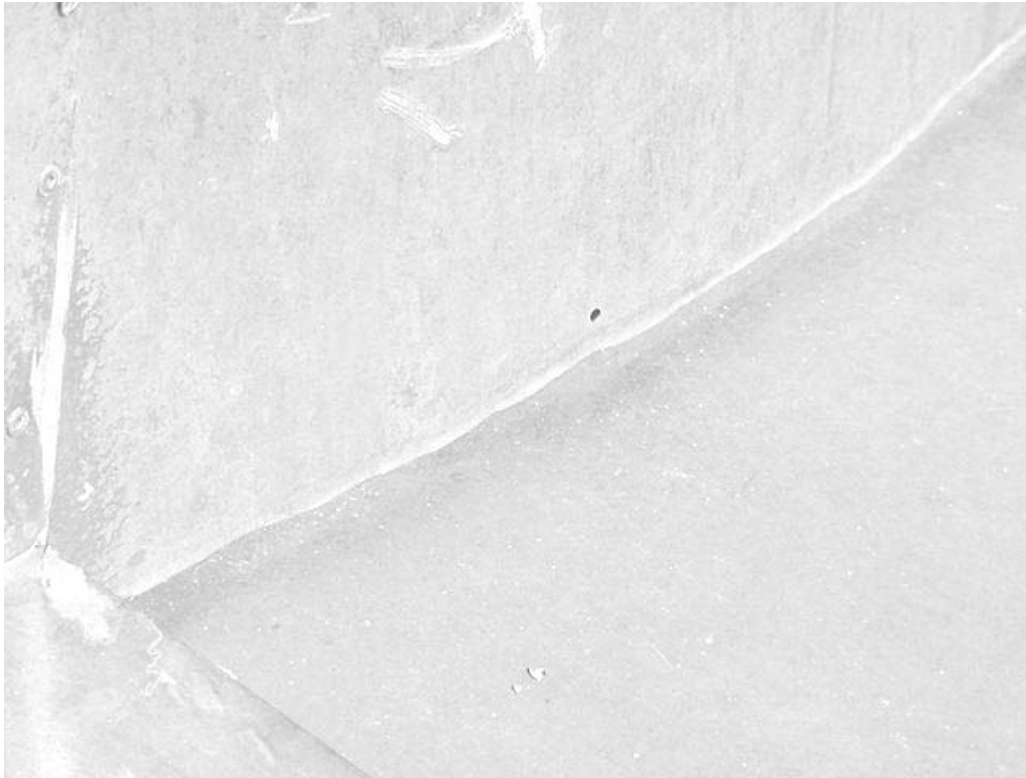
Picture 10

Copper Roof Section with Missing Rivets

12. Repair loose or missing rivets in the copper roof above the gymnasium.
13. Add an extension to the drainpipe on the atrium to deliver rainwater to ground level to prevent splashing onto the window system.
14. Render the horizontal seams in the rubber membrane roof watertight to prevent water penetration.
15. Seal the hole, noted in Picture 8, to prevent rainwater penetration along ductwork.
16. Seal the condensation drains for AHUs during the heating season to prevent entrainment of odors from roof drains. It is imperative that once the AHUs are switched to air conditioning mode that stoppers in the condensation drains be removed. *Failure to remove stoppers can result in water backup into the AHU cabinet, which can produce microbial growth.*

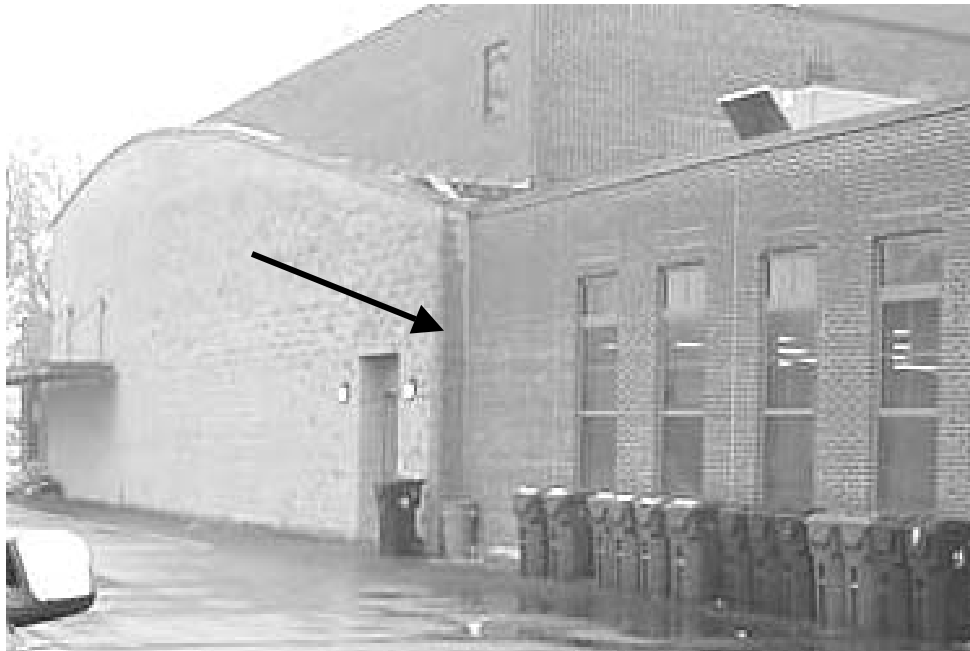
Picture 11

The gymnasium exterior walls and atrium have several potential water penetration problems. A corner of the gymnasium allows for rainwater to freely moisten the exterior wall system, as demonstrated by the green discoloration of the brick from runoff from the copper roof (see Picture 11). Chronic moistening of the brickwork in this manner may lead to erosion and possible water penetration.

Brick Discoloration on Corner of Gymnasium, Indicating Excessive Rainwater Exposure

10. Seal holes in wall penetrations for support of awning roof to eliminate water penetration.
11. Install a gutters/downspouts to prevent excessive water exposure to gymnasium exterior brick.

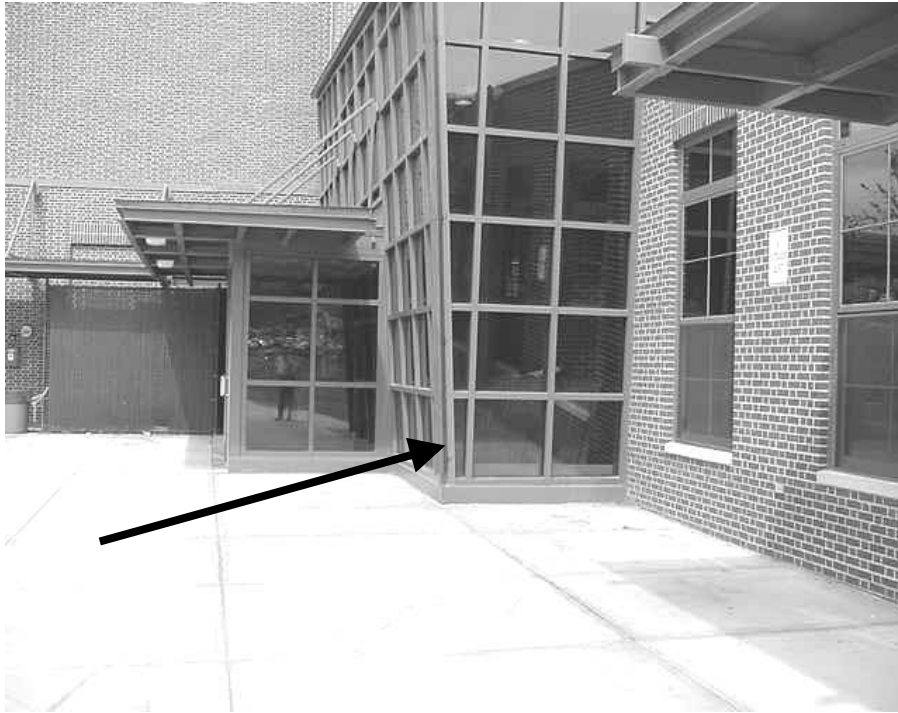
Picture 12

Atrium Downspout That Terminates Several Feet above the Sidewalk

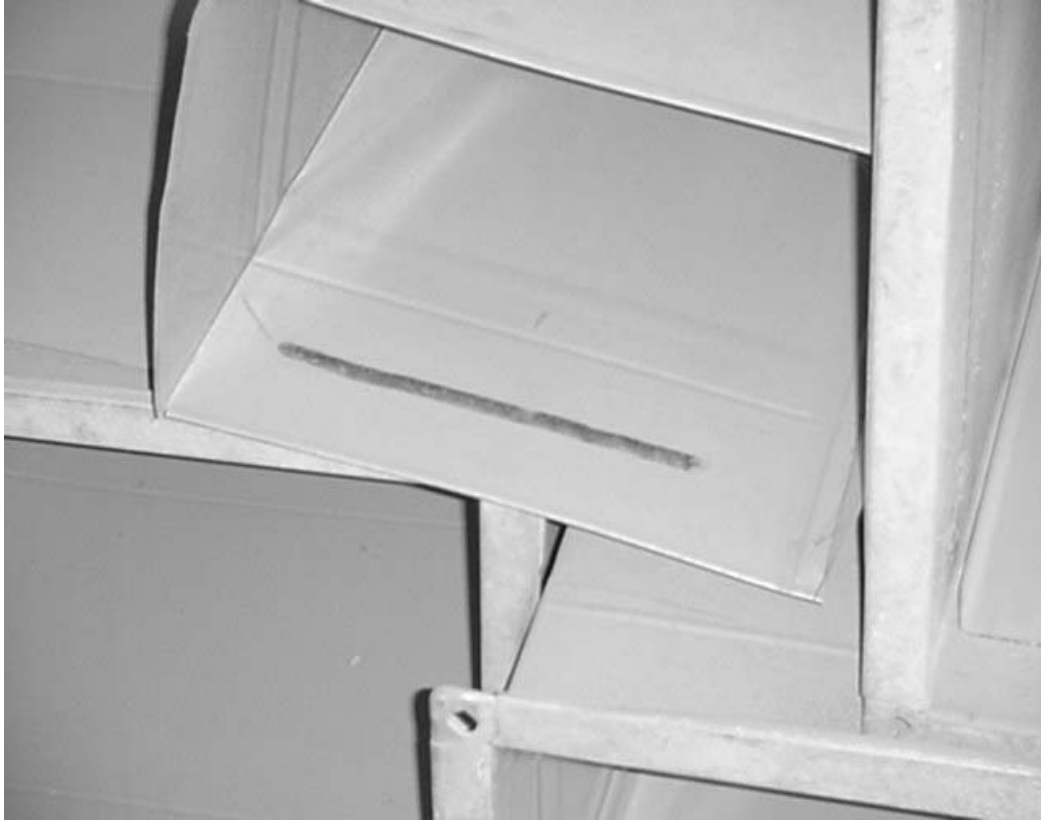
Picture 13

**Dust Contaminated Ductwork, in GMS during Renovations
(Line Drawn in Dust by BEHA Inspector)**

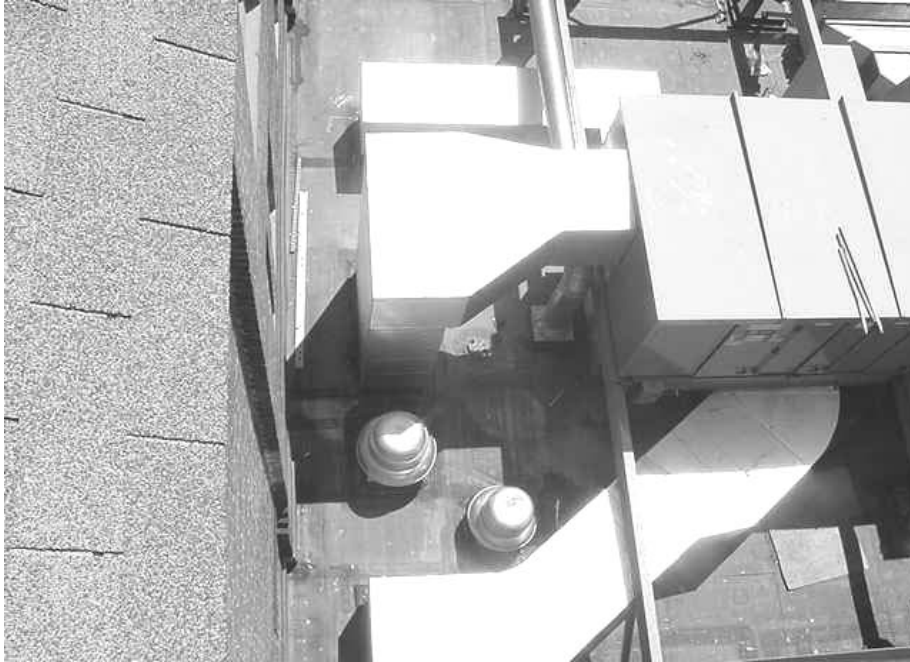
Picture 14

the building filled in the courtyard with the lower roof and HVAC equipment. The HVAC equipment and ductwork in the woodshop courtyard will be chronically exposed to rainwater and possibly falling ice and snow due to its proximity below the auditorium's roof edge (see Picture 13). In order to prevent water penetration into and premature degradation of both HVAC equipment and ductwork, it is strongly recommended that a gutter/downspout system be installed to direct rainwater from this equipment. In addition, installation of some device that breaks up ice and snow should be installed to decrease the chance of damage to rooftop HVAC equipment below this roof.

HVAC Equipment and Ductwork below the Auditorium Roof Edge

3. Install a gutter system along the edge of the peaked roof over the auditorium to prevent excessive water exposure to AHUs and ducts on lower roofs.
4. Examine the feasibility of installing local exhaust ventilation for publishing center.
5. Examine the feasibility of installing a backsplash on the back of the awning roofs to prevent excessive water exposure to exterior brickwork.

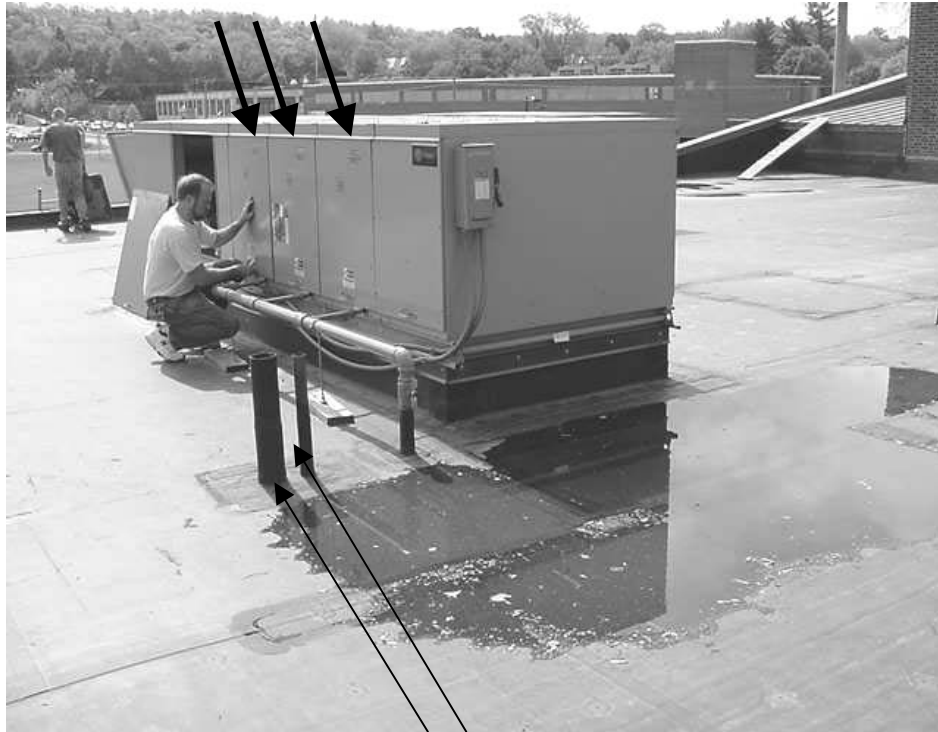
Picture 17

Reports of sewer gas odor were reported in several areas within the GMS. Of note is the lower roof on the northeast section of the building. A sewer vent pipe was located below an AHU that has small vents, which draw outdoor air into the cabinet (see Picture 17). Under certain wind conditions, sewer gas from this vent may be entrained by this AHU. The AHU in the north courtyard was found drawing air from the roof level above a roof drain (see Pictures 18

Sewer Vent Pipes

AHU Vents Drawing Sewer Odor from Vent Pipe(s)

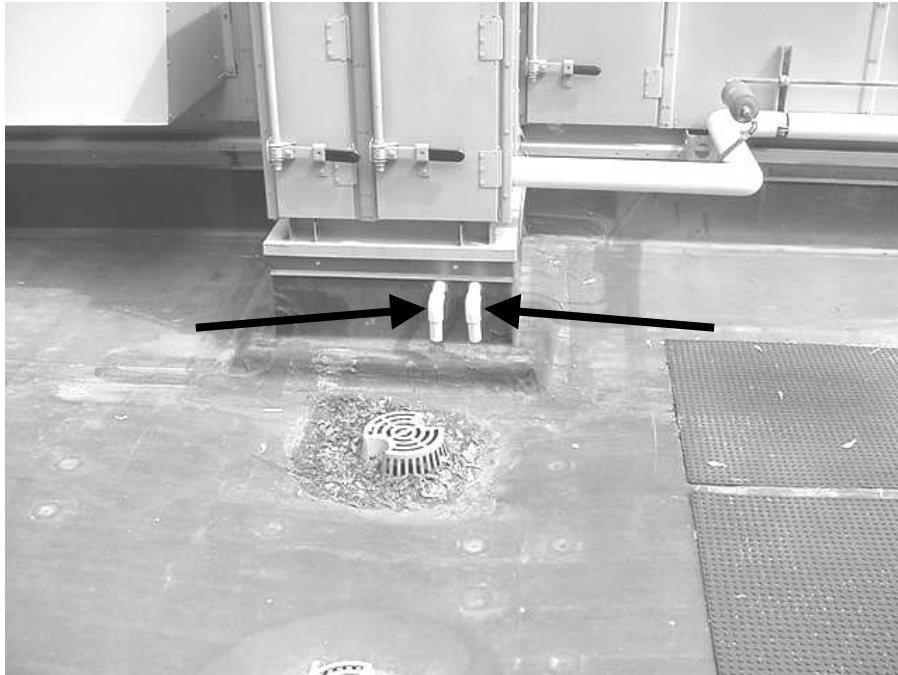
Picture 18

and 19). Under certain conditions, the AHU may draw odors from this drain or from the accumulated materials caught in the strainer.

Condensation Drains for North Courtyard AHU

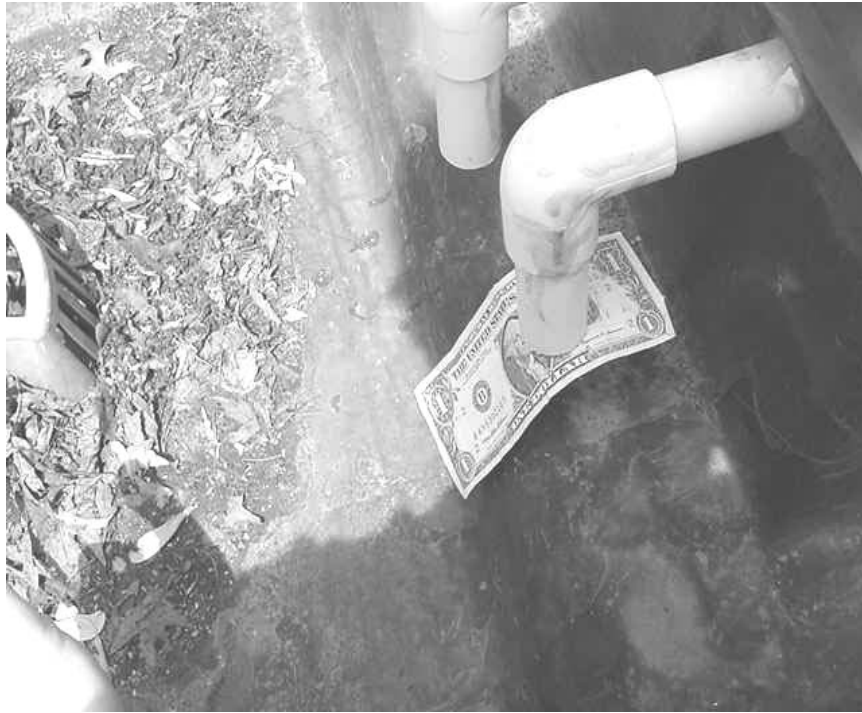
Picture 19

Draw of Air into Drain Sufficient to Hold Paper to Pipe

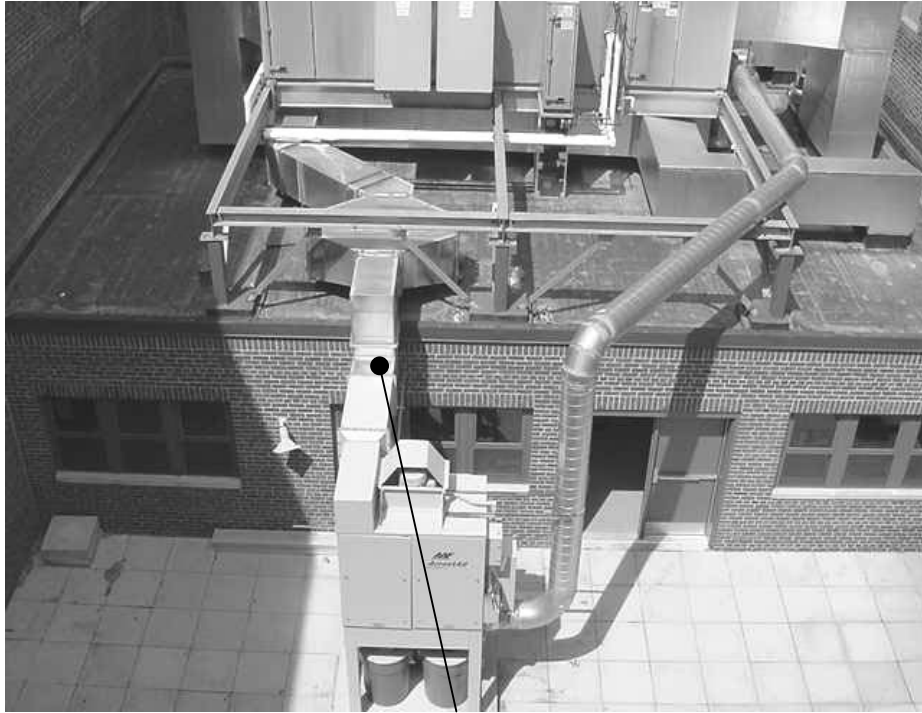
Picture 20

BEHA staff noted a significant amount of wood dust in the wood shop return vent, which indicates that sawdust is aerosolized from machinery and is entrained by (drawn into) the ventilation system. The wood shop contains a dedicated AHU. The interior of the AHU was examined and significant amounts of wood dust were found accumulated in its interior. The woodshop has local exhaust ventilation for wood cutting/sanding machines that are connected to a wood dust collector in the courtyard (see Picture 20). A duct is connected to the top of the wood dust collector and appears to be ducted into the wood shop fresh air intake AHU. Wood

Wood Dust Collector

Wood Dust Collector in Courtyard, Note Duct on top of Wood Dust Collector

1. The exhaust system for the wood dust collector should be reconfigured to prevent the introduction of wood dust into the wood shop. Venting the wood dust collector vent into the courtyard may result in wood dust entrainment through the “doghouse” vents or the AHU on the roof above the wood dust collector. If not feasible, consideration should be given to moving the wood shop to an exterior wall or discontinue the use of the wood dust collector.
2. Consult with the Greenfield Fire Department concerning the adequacy of ductwork currently used as the exhaust vent for the kiln. The exhaust vent system for the kiln should be reconfigured to prevent the introduction of kiln pollutants into the general exhaust system. Venting the pottery kiln into the courtyard may also result in the
